**A Study Of South Fork
Shenandoah Tributaries**

Rockingham County, Virginia

APPENDIX V

DRY RUN

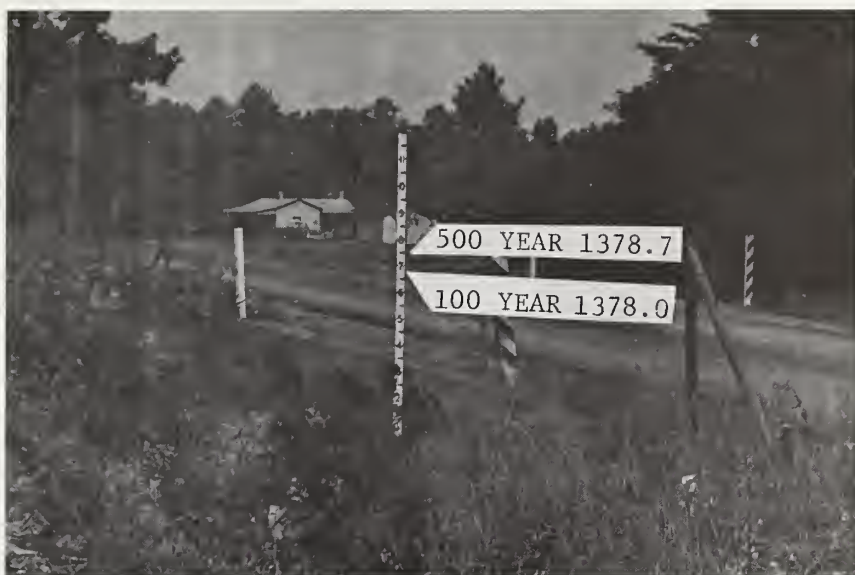
Fig. 2 Looking downstream (NW) as Route 625 crosses Dry Run at Section DR-12.

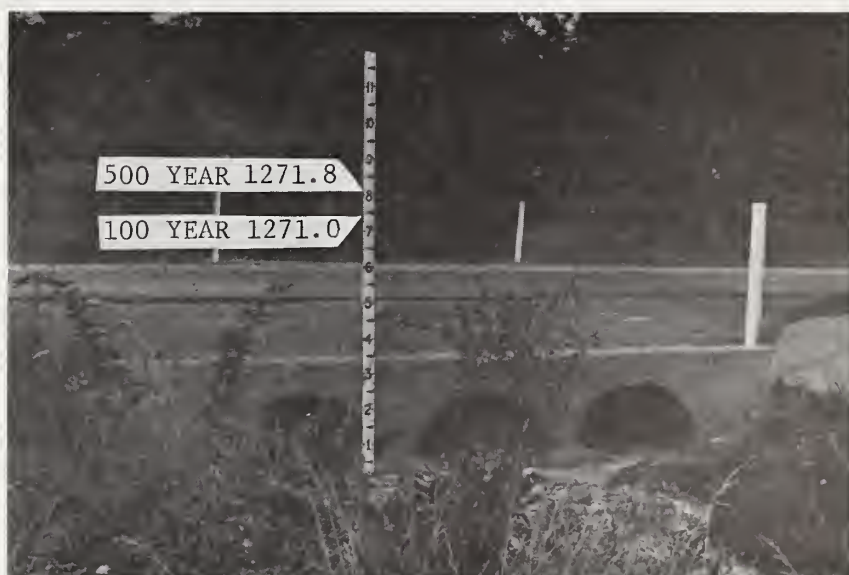
Fig. 3 Looking downstream (W) as Route 625 crosses Dry Run at Section DR-16.

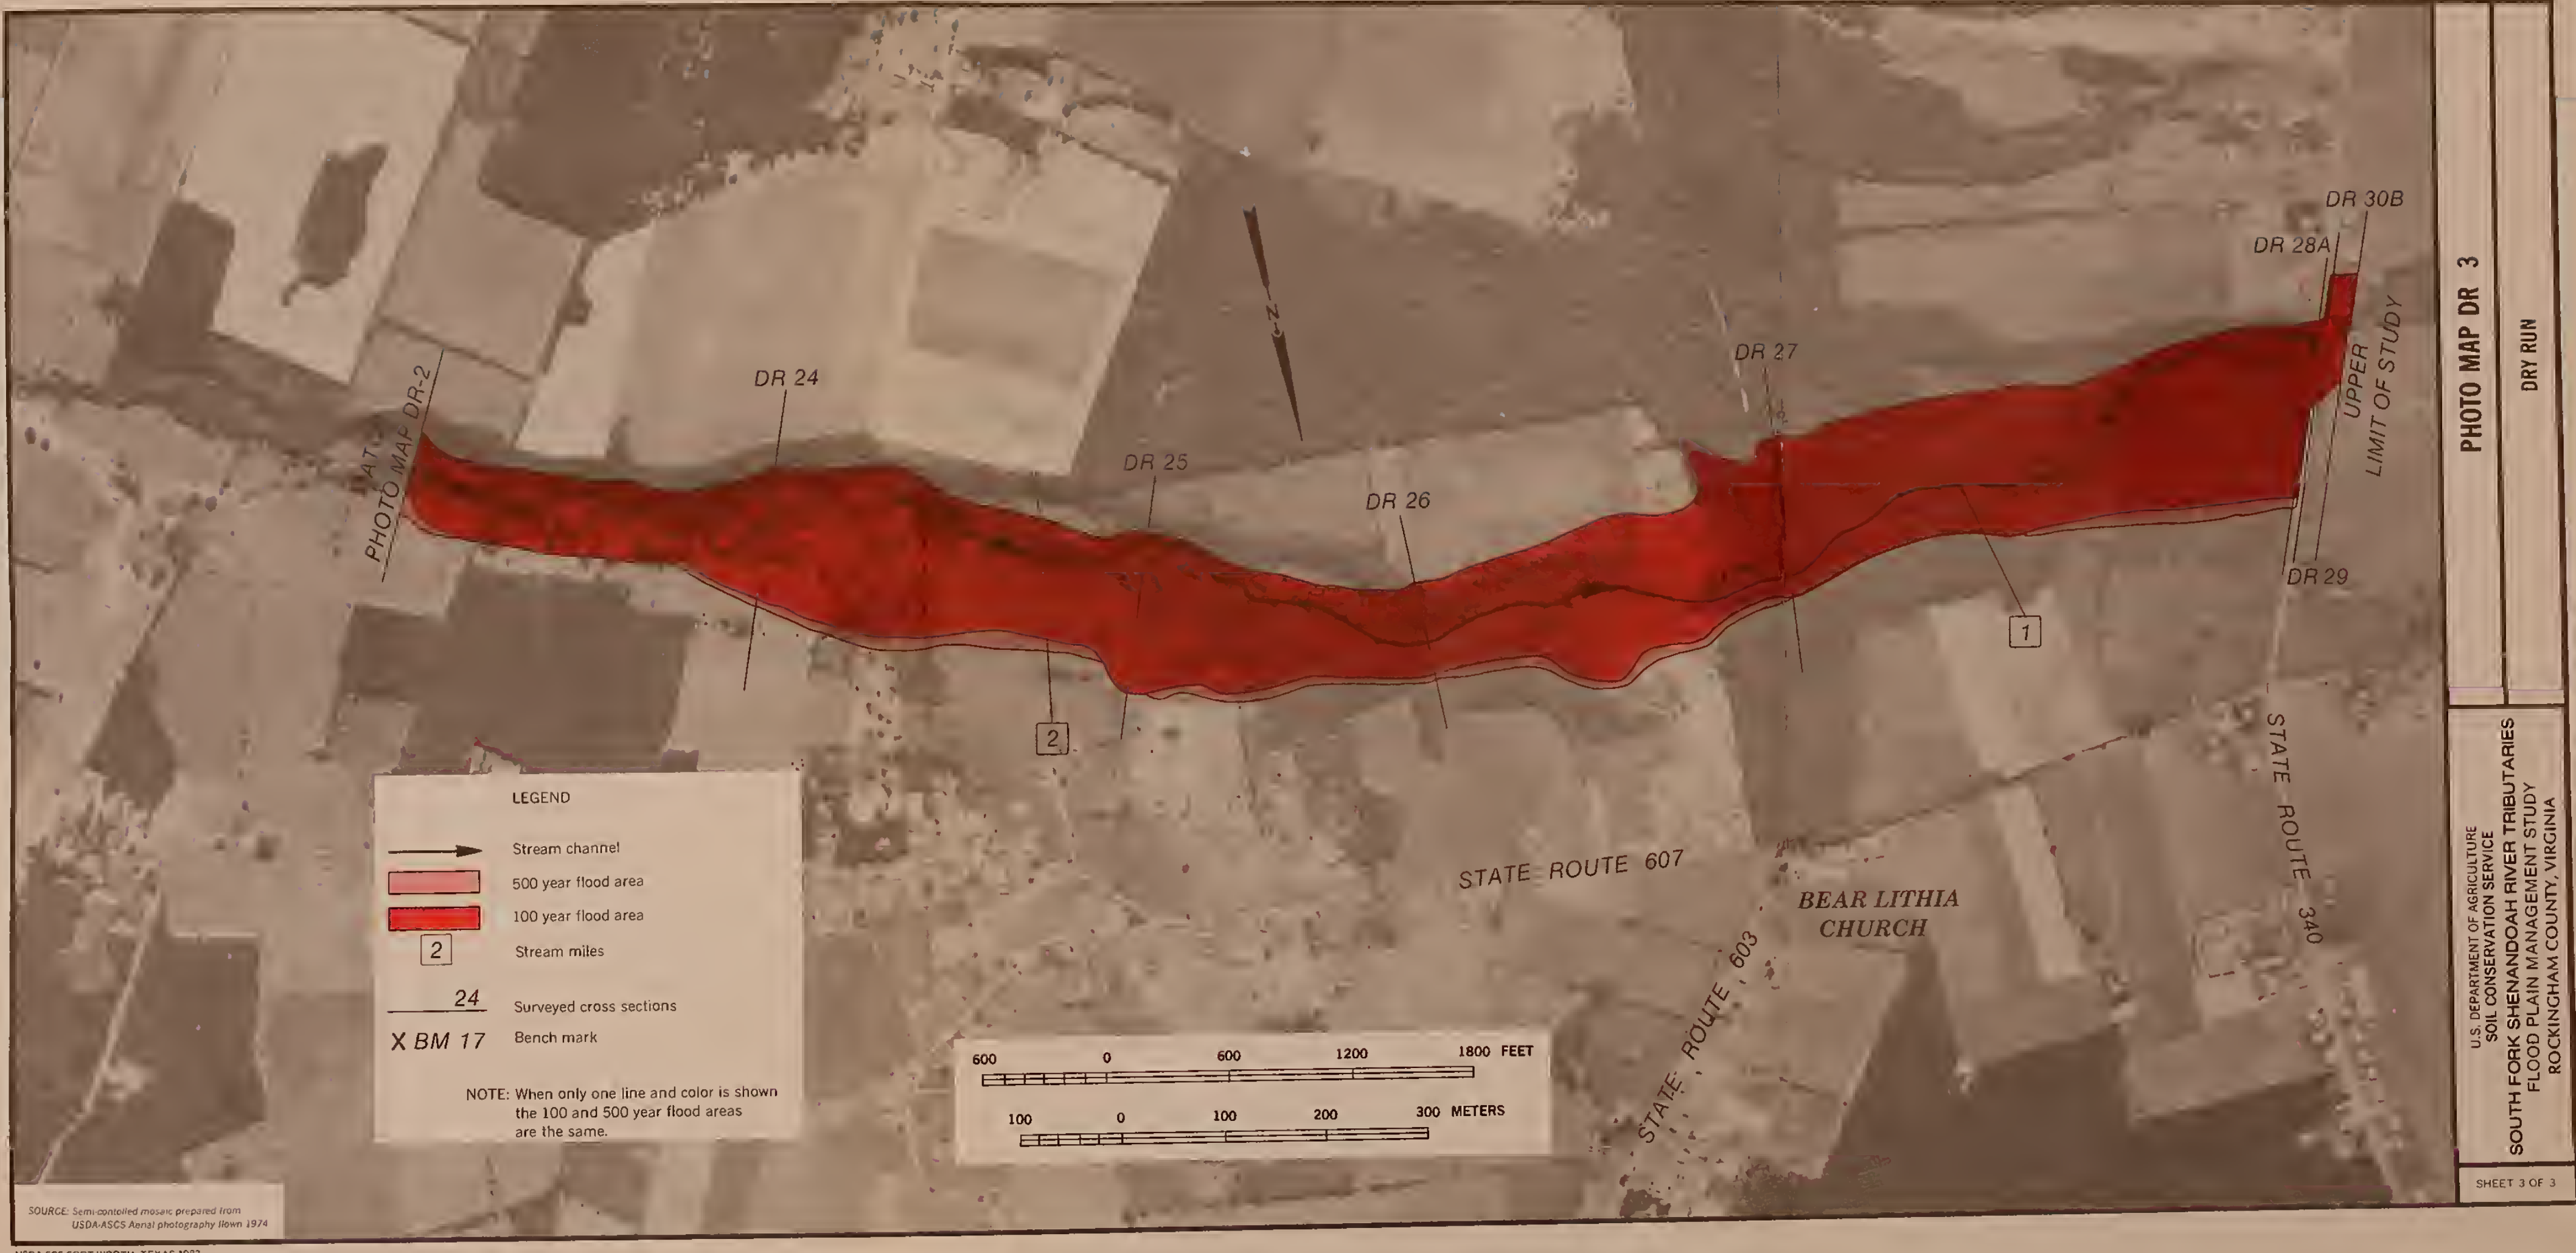
MAM 11/80 Plate 1 of 5
See
Photomap
1 & 2

Flood profile plates provide elevations of the 10, 50, 100 and 500-year floods at any location along the length of the streams. The elevations and discharges of the 10, 25, 50, 100 and 500-year flood at each surveyed cross section are given in Table DR-1. Sample cross sections illustrated how the flood area boundaries were located. Table DR-2 provides the description and elevation of benchmarks which are located on the photomaps.

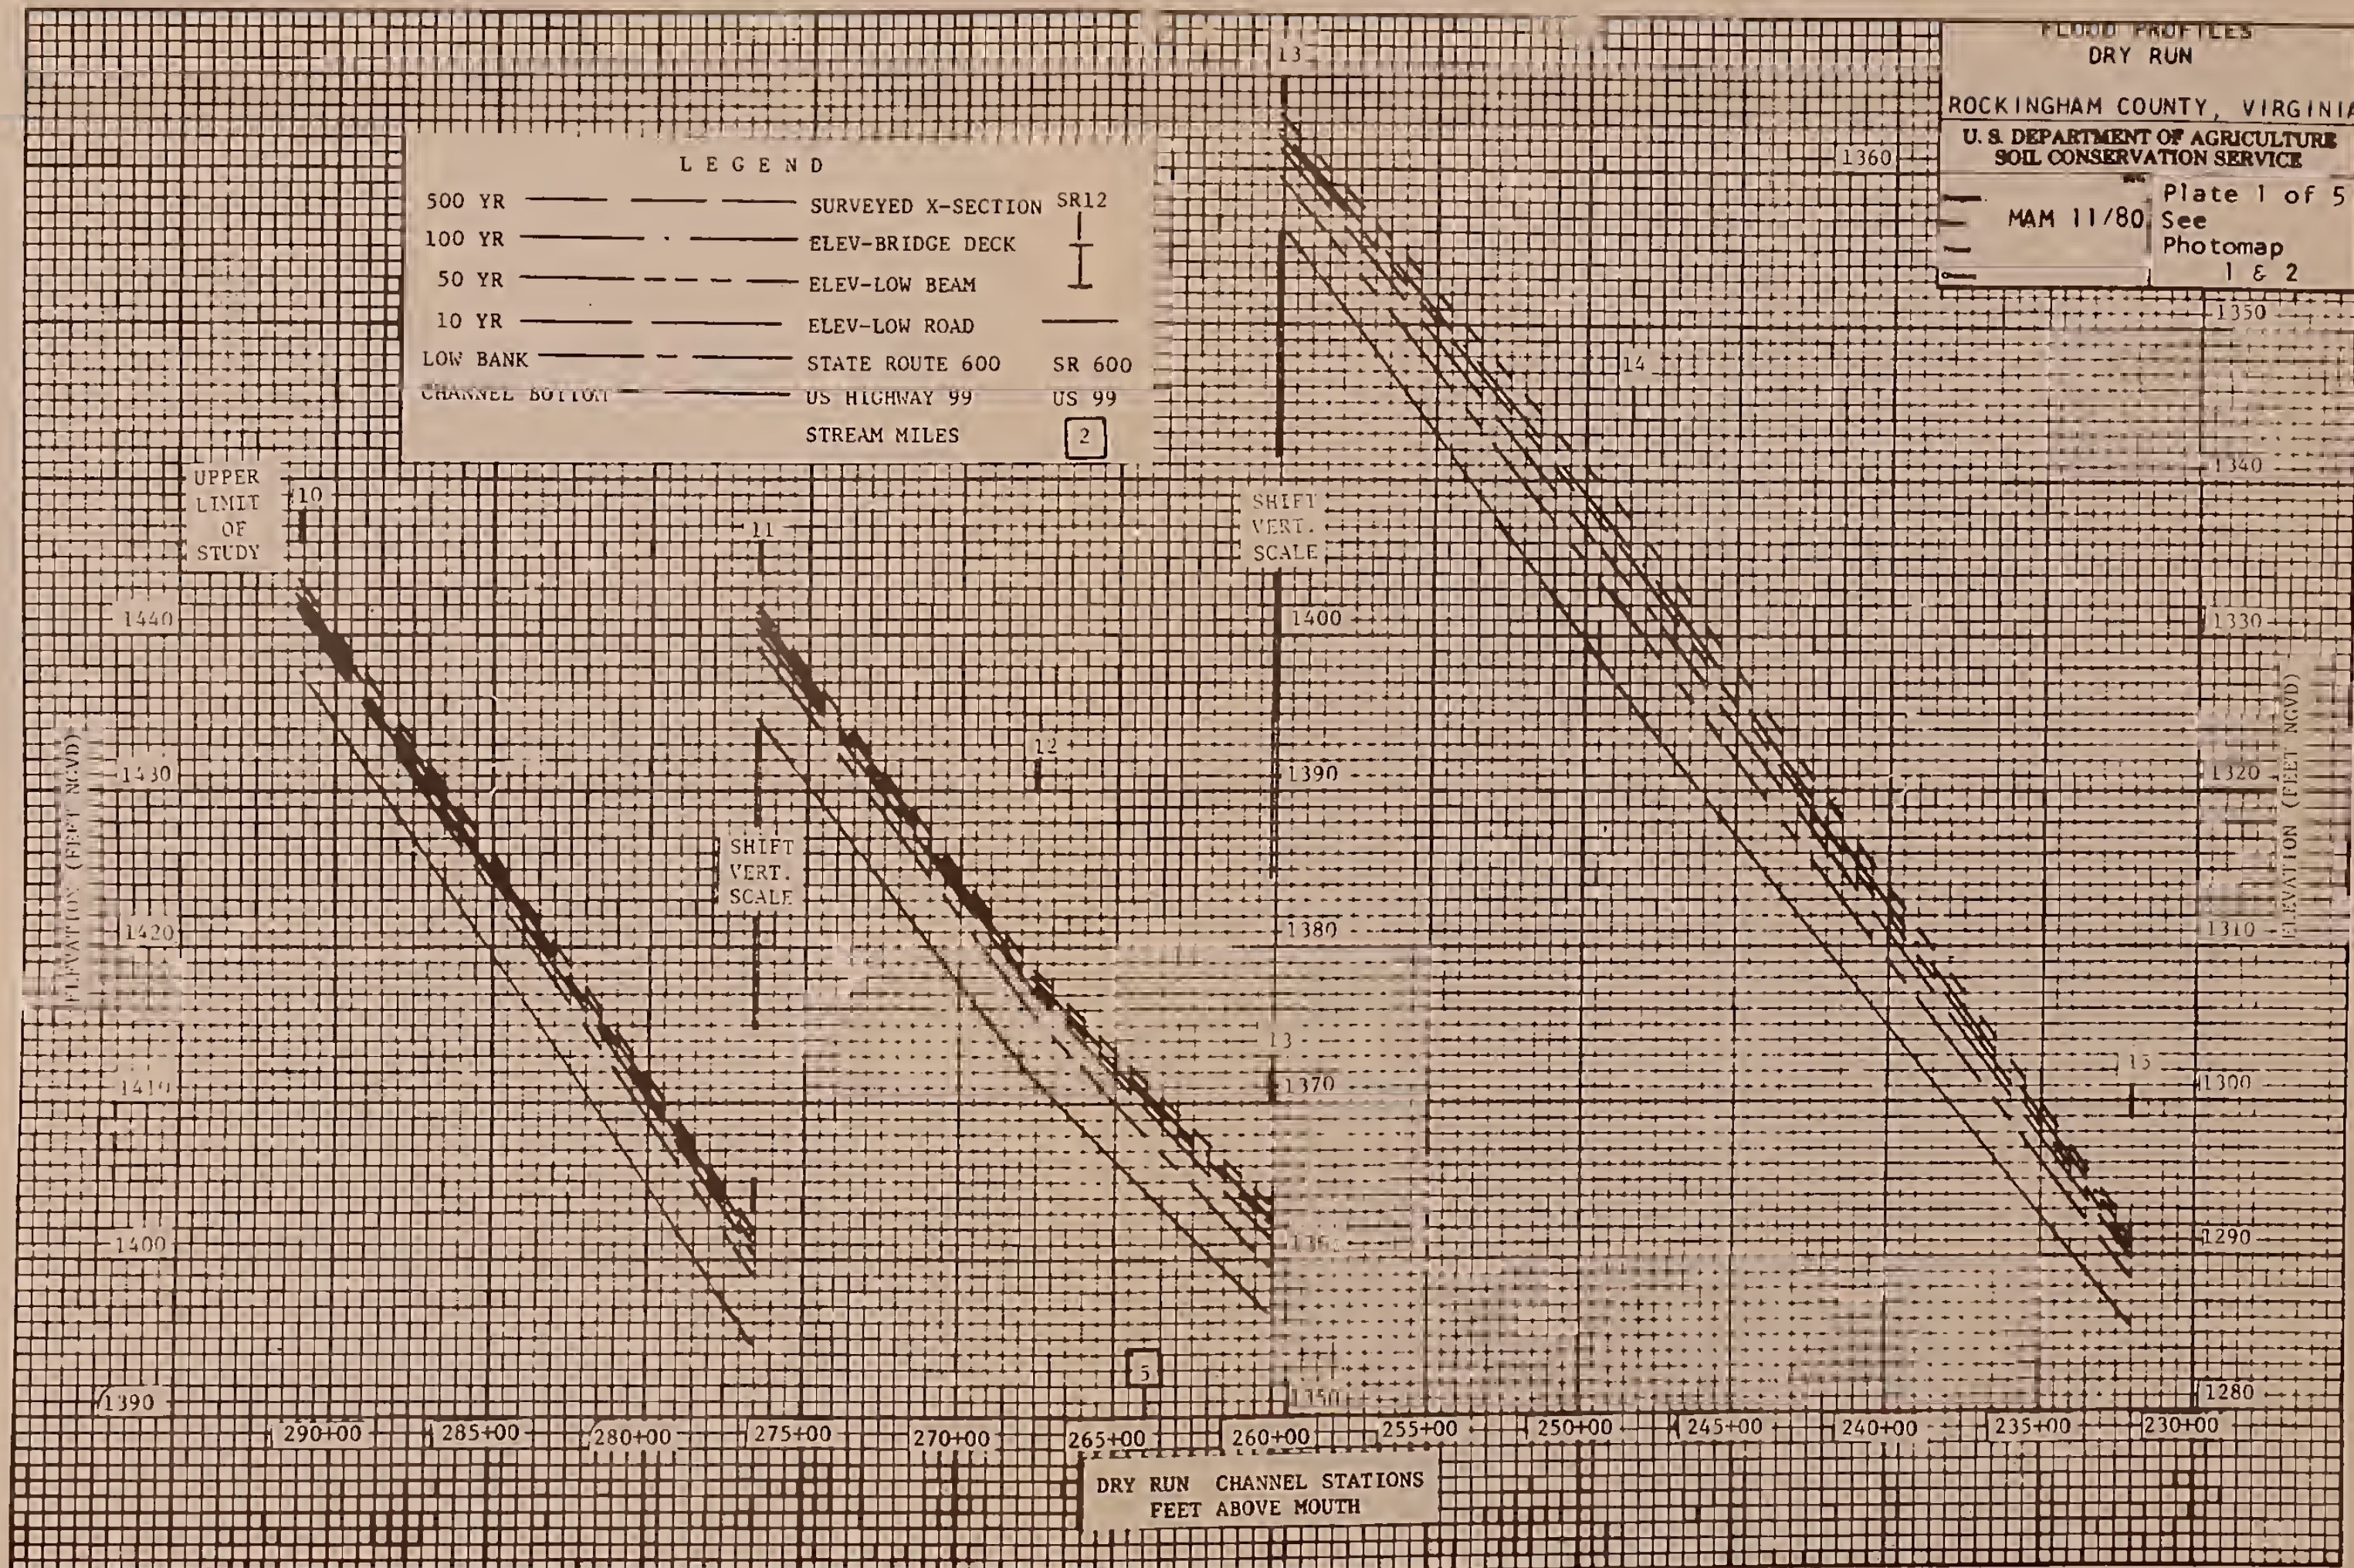
MAM 11/80 Plate 2 of 5
See Photomap 2

FLOOD PROFILES DRY RUN

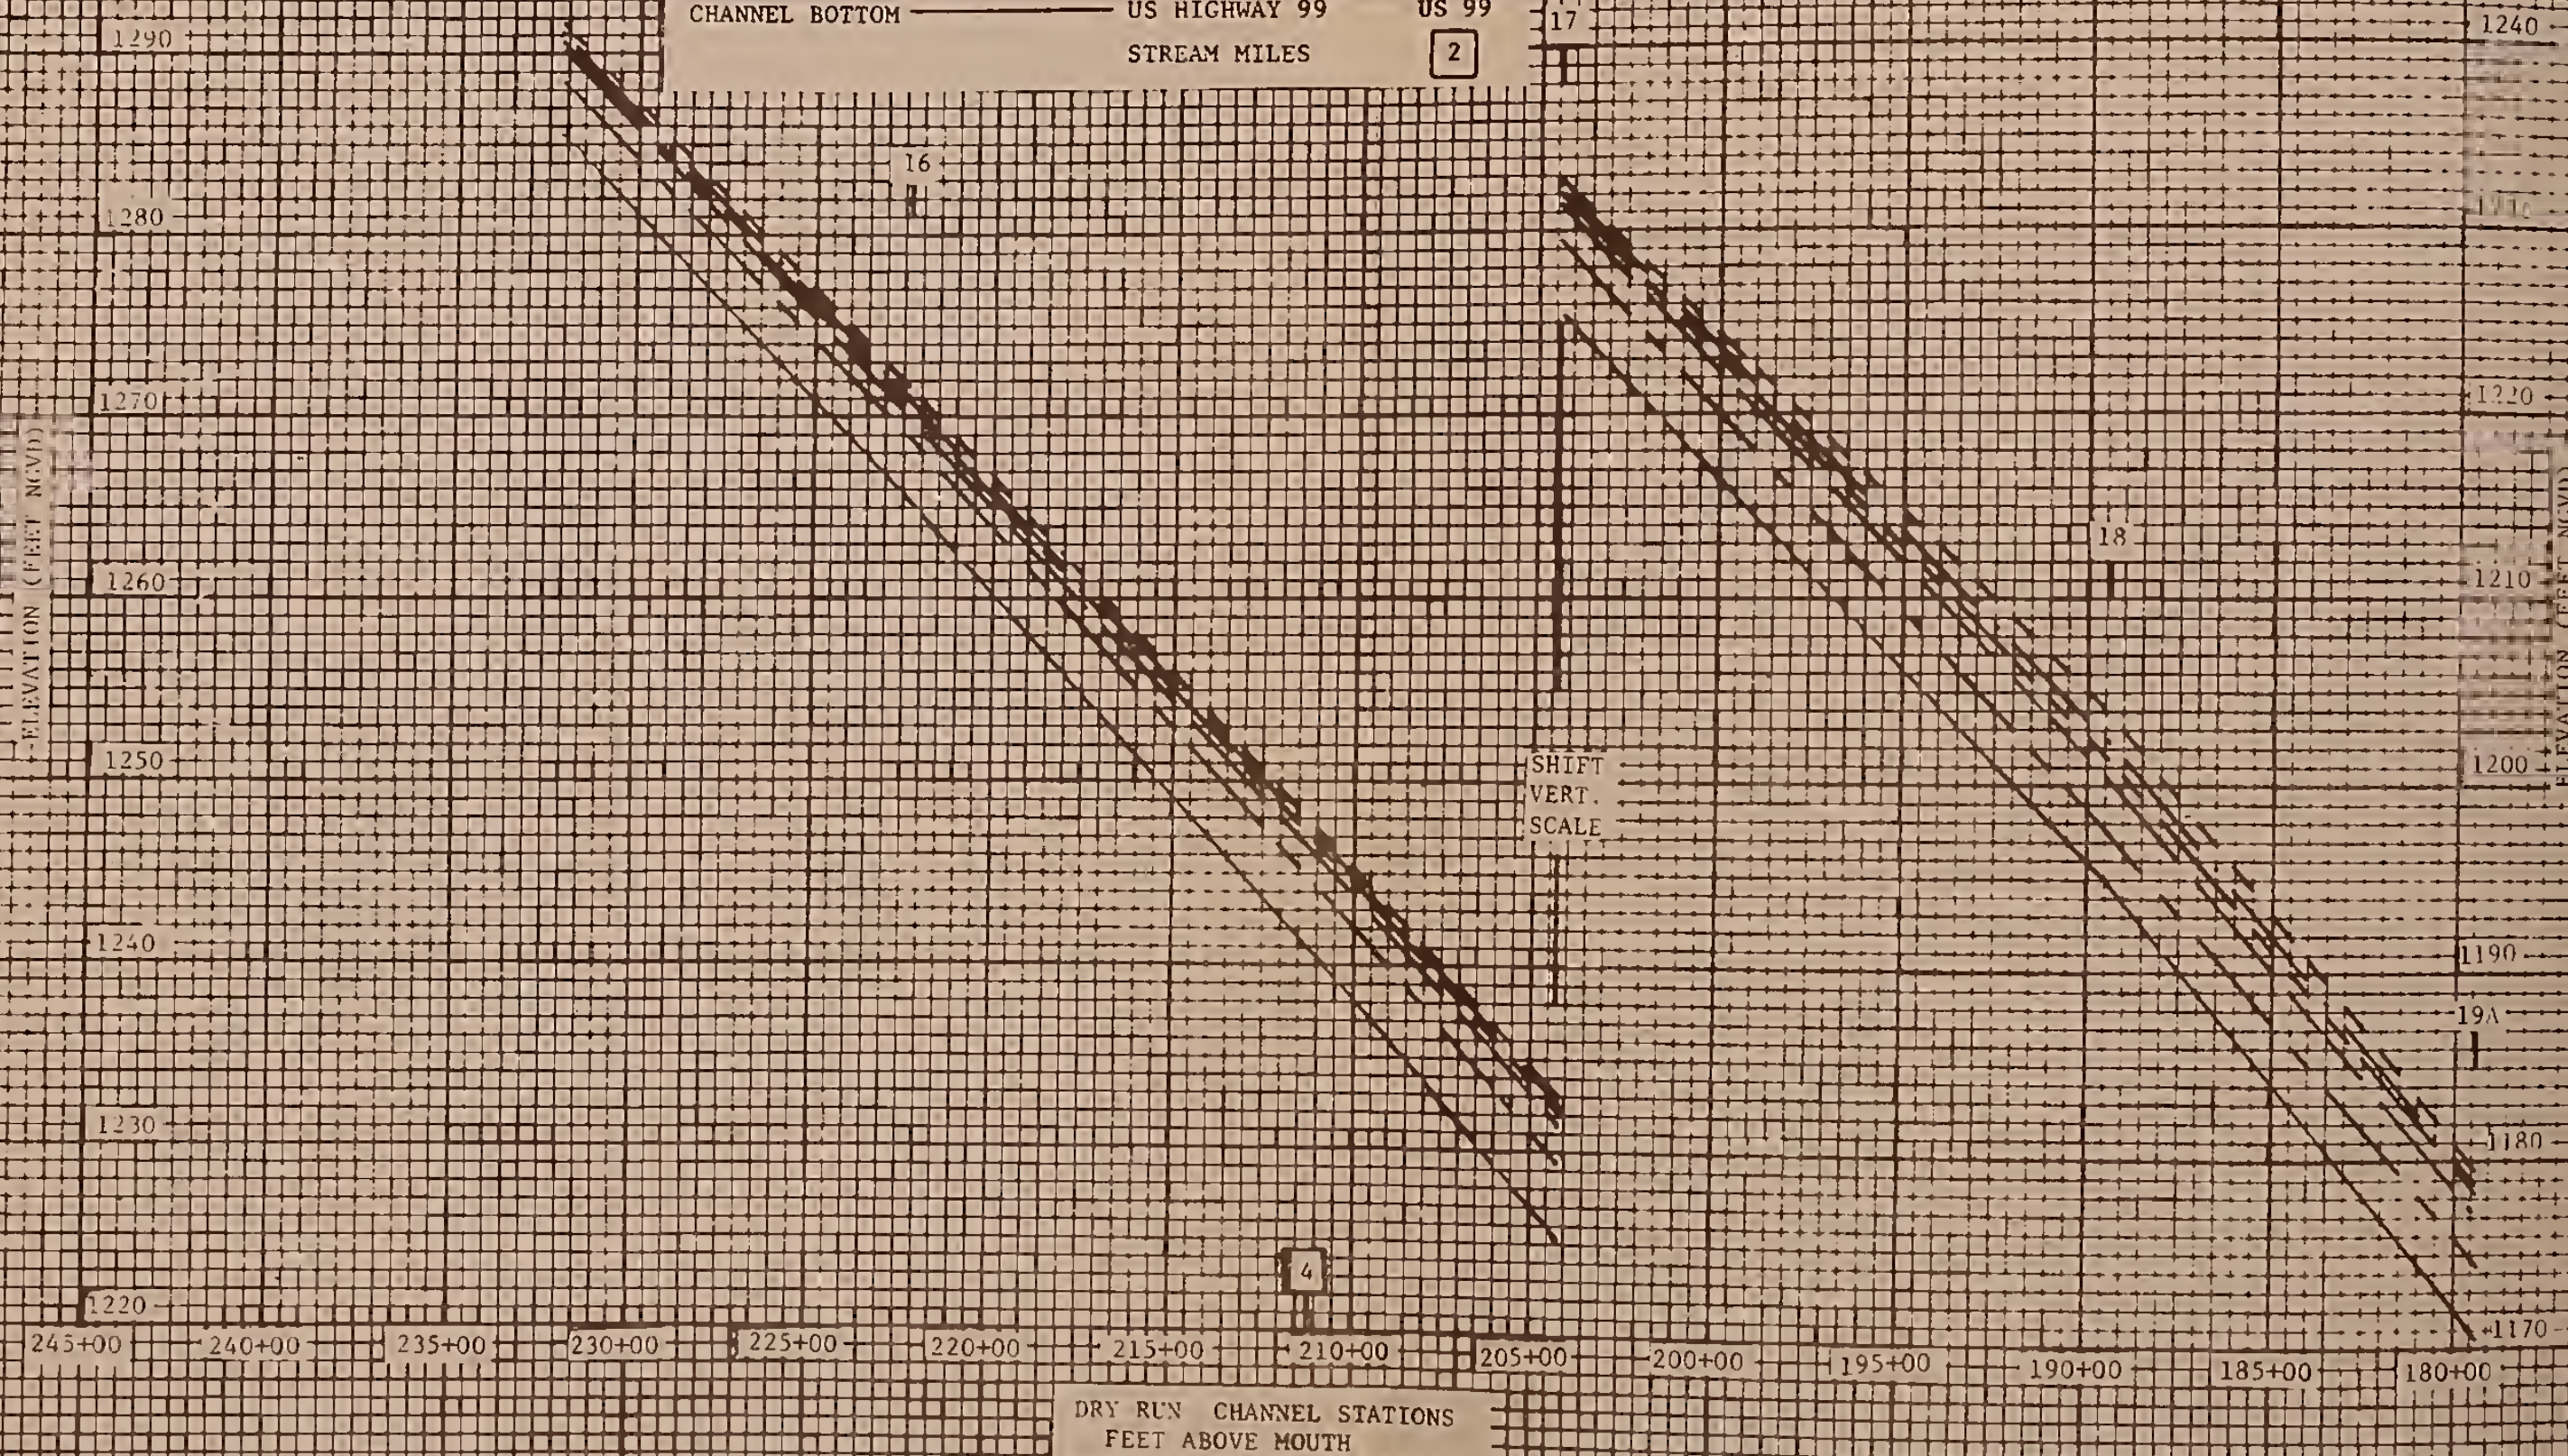
Plate 3 of 5
See
Photomap
2 & 3

FLOOD PROFILES
DRY RUN

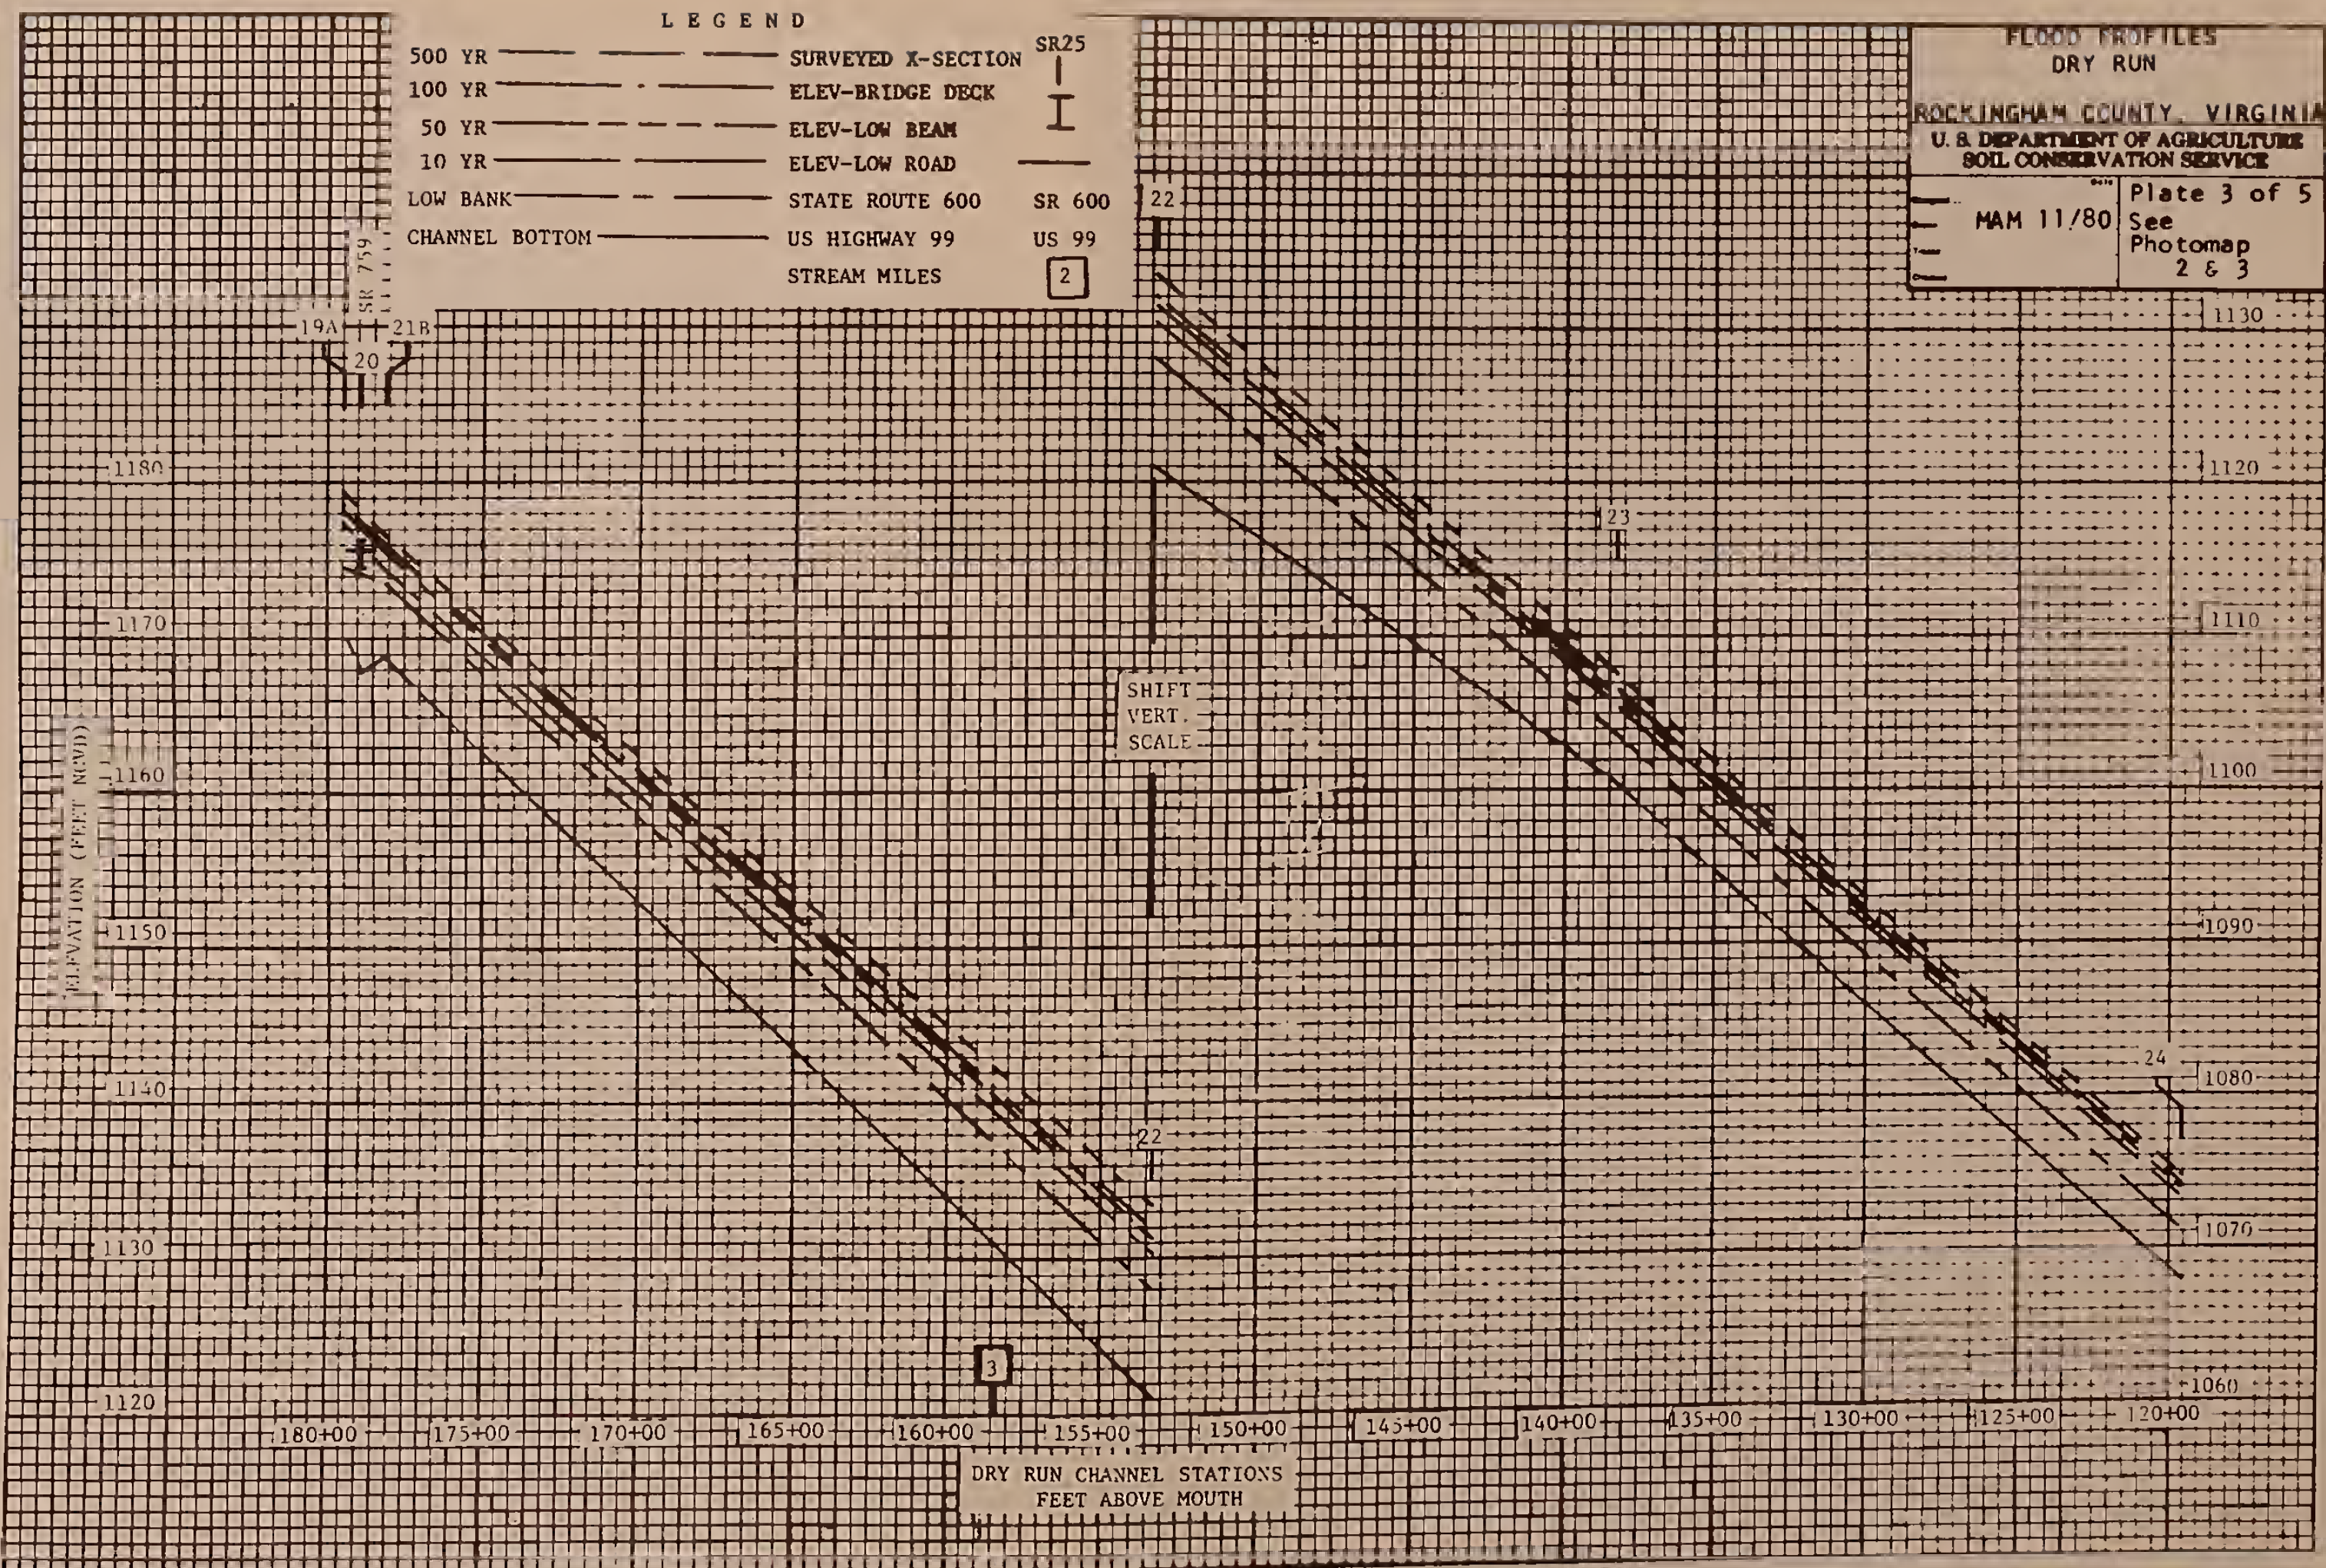
Date: Plate 4 of 5
MAM 11/80 See
Photomap 3

FLOOD PROFILES DRY RUN

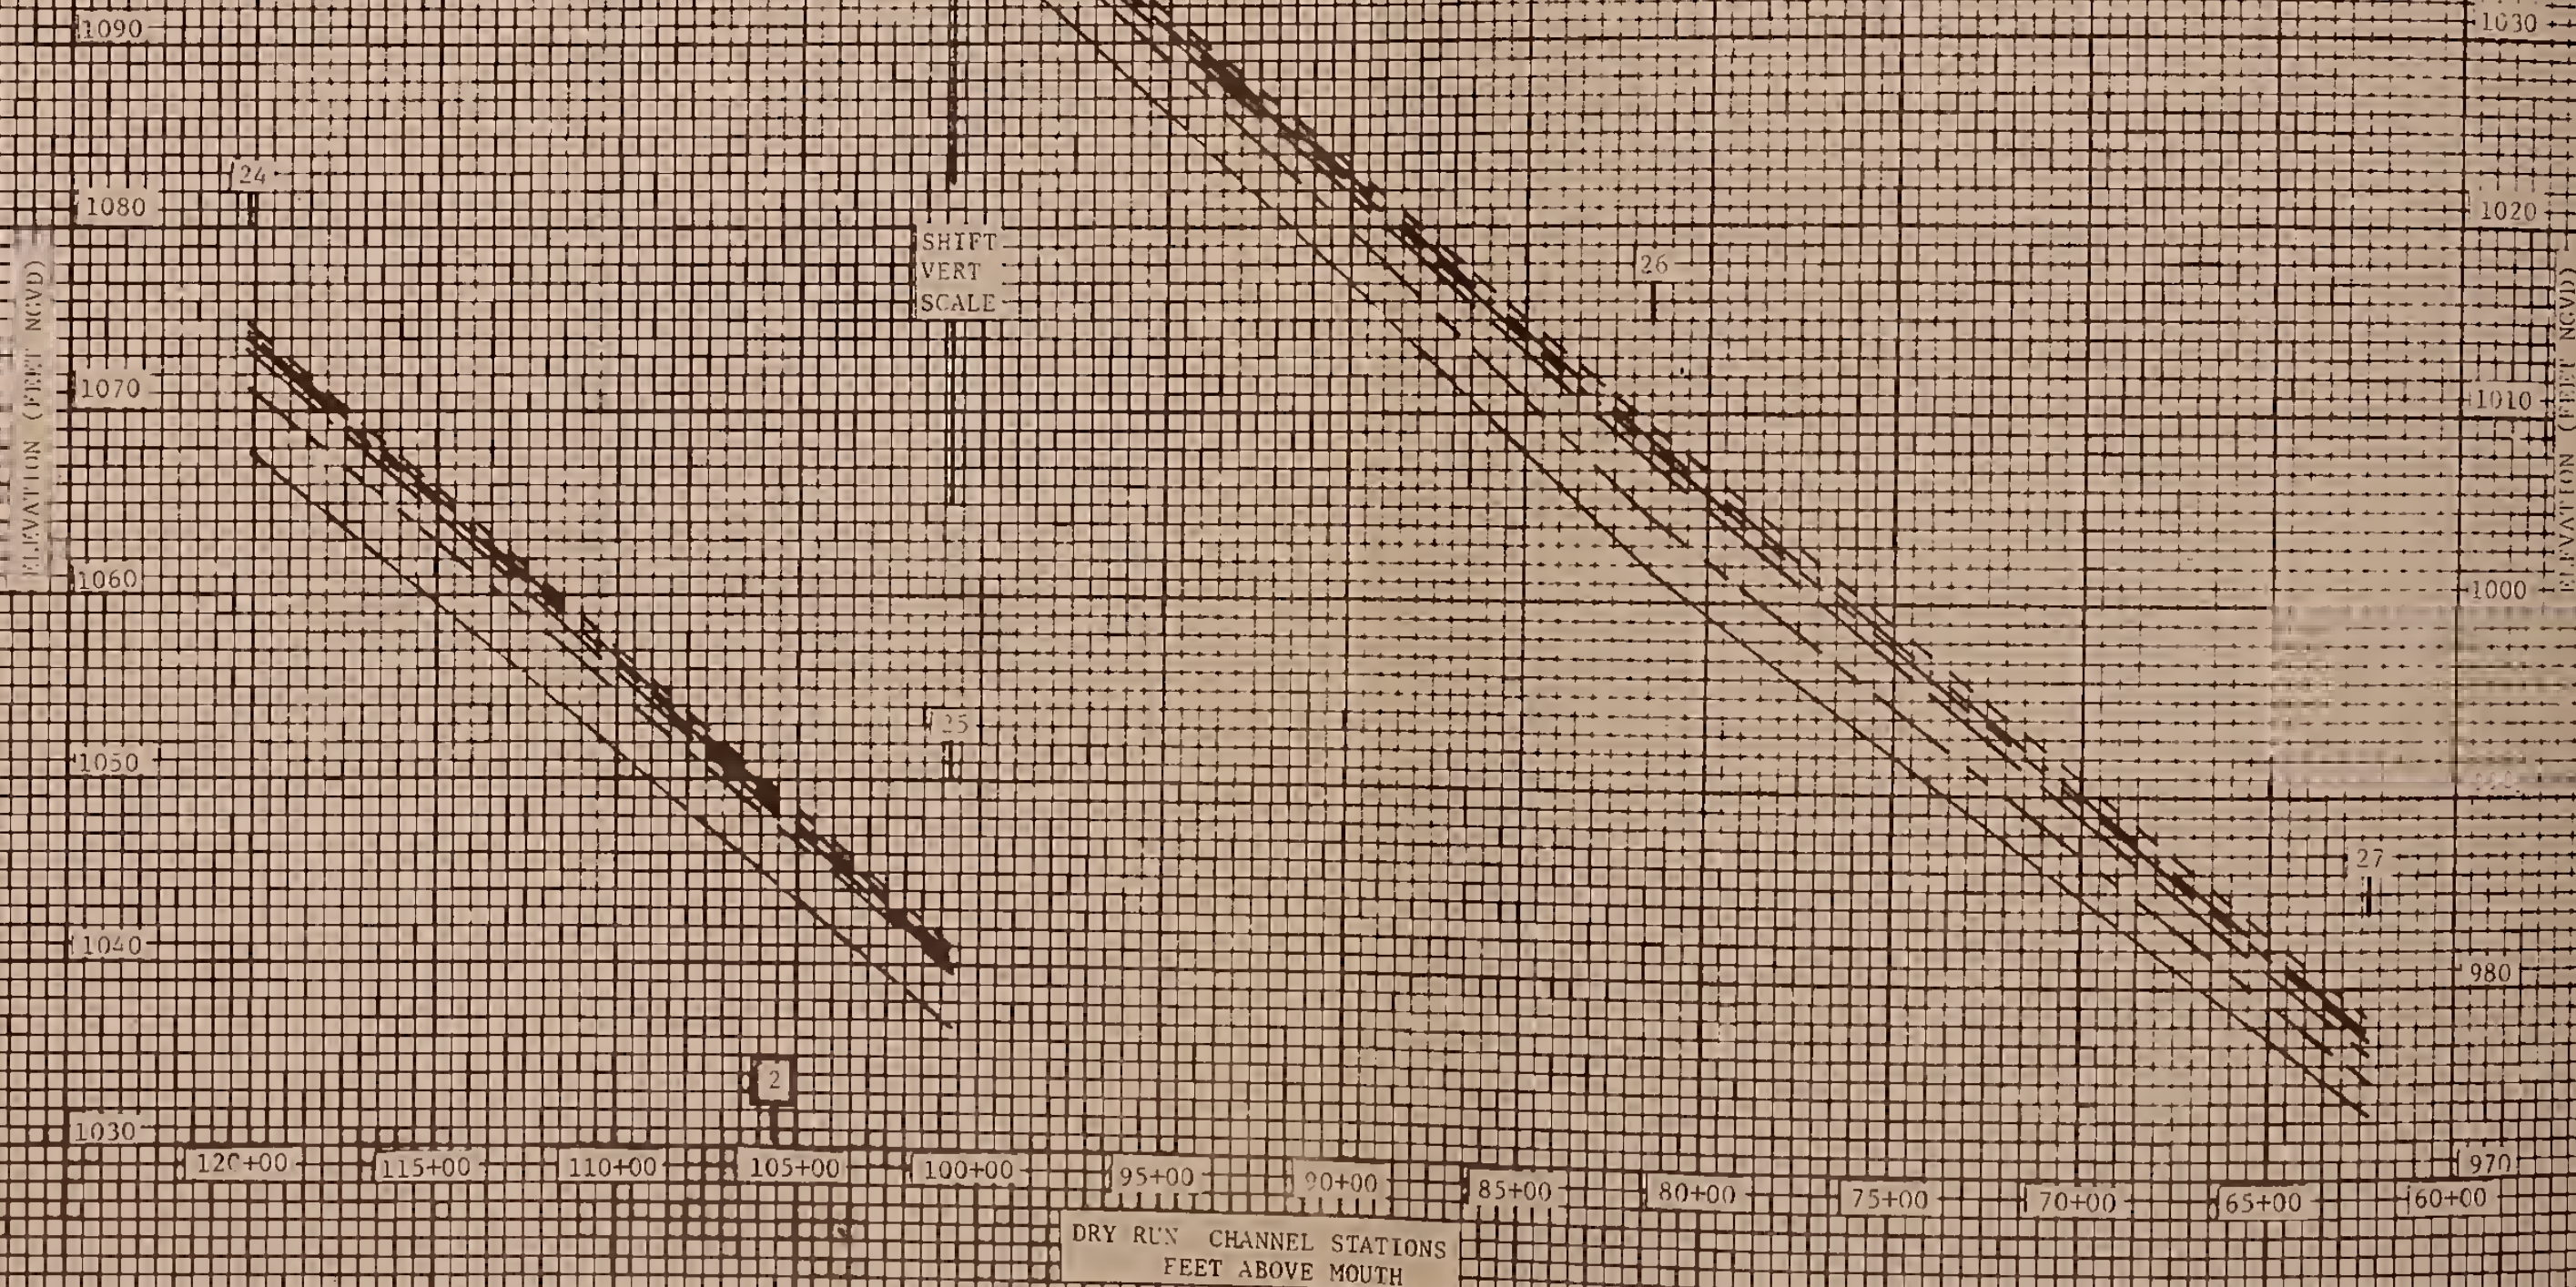
MAM 11/80 Plate 5 of 5
 See Photomap 3

FLOOD PROFILES
 DRY RUN
 ROCKINGHAM COUNTY, VIRGINIA
 U. S. DEPARTMENT OF AGRICULTURE
 SOIL CONSERVATION SERVICE

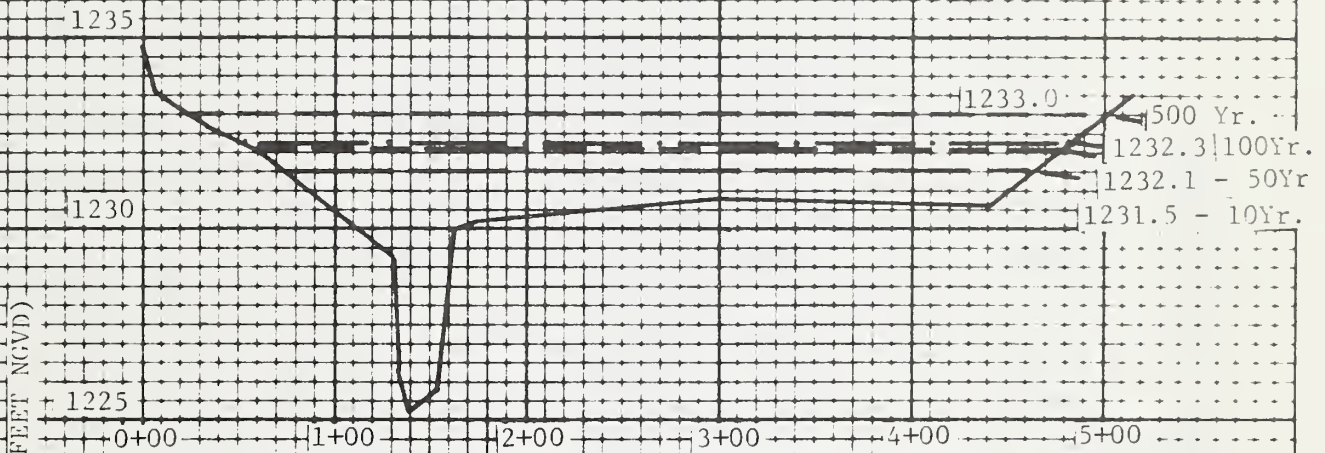
CROSS SECTION 17

**TYPICAL CROSS SECTIONS
DRY RUN**
ROCKINGHAM COUNTY, VIRGINIA
**U. S. DEPARTMENT OF AGRICULTURE
SOIL CONSERVATION SERVICE**
